Manhole Inspection Summary

Manhole # S31GG_008MH

Location Address: **201 LANVALE ST**

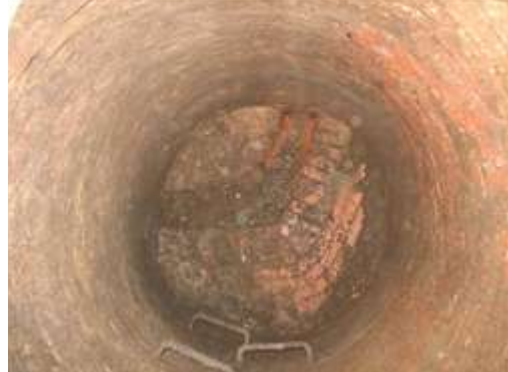
Top View

Evidence of surcharge - Bench debris.
Channel debris.

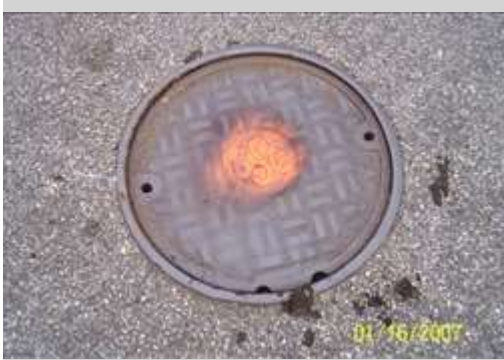
Defect

Worn cover. Subject to ponding.

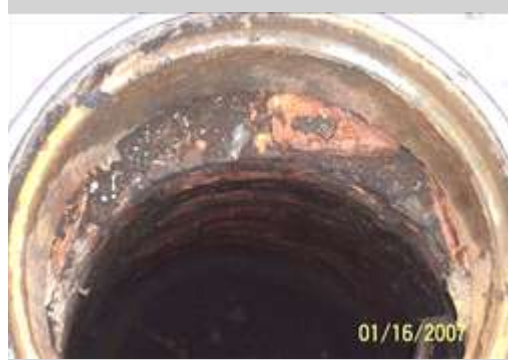
Defect

Frame leaks. Frame offset. Adjustment
deterioration and infiltration. Corbel and
Barrel infiltration.

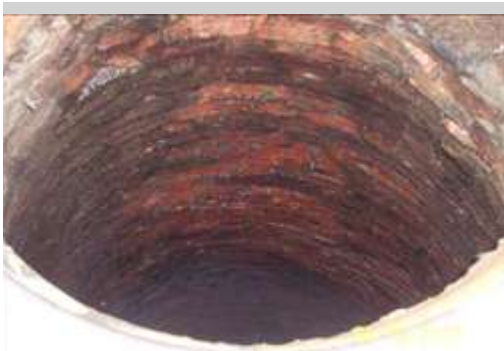
Defect

Adjustment deterioration and infiltration.
Corbel and Barrel infiltration - other side.

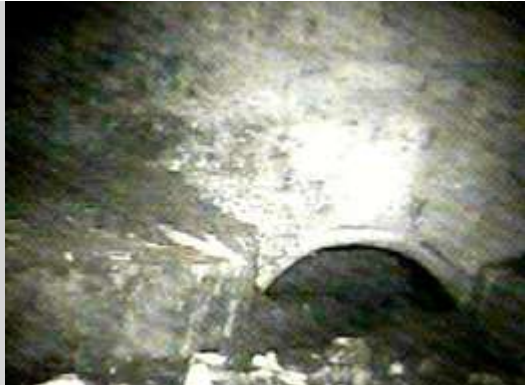
8 in. Circular Gravity Sewer Pipe Out @ 12 O'Clock

Deposits: ☐ None ☒ **Mud** ☐ Sludge ☒ **Debris** ☐ Grease

Silt Depth: **3** (in.) Deposits Extent: **Medium**

Infiltration: **Evidence** Pipe Seal Cond: **Unknown**

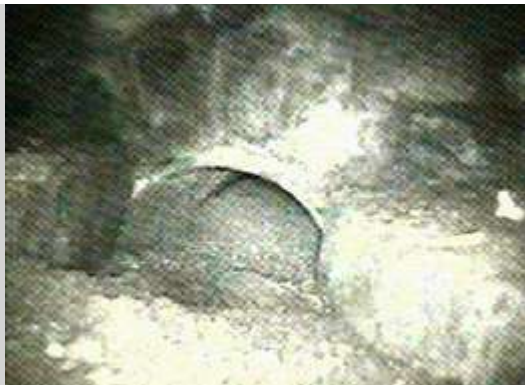
8 in. Circular Gravity Sewer Pipe In @ 9 O'Clock

Deposits: ☐ None ☒ **Mud** ☐ Sludge ☒ **Debris** ☐ Grease

Silt Depth: **3** (in.) Deposits Extent: **Medium**
